**The Incorporation of Pitting
Corrosion Damage into F-111
Fatigue Life Modelling**

DSTO-RR-0237

**Airframes and Engines Division
Aeronautical and Maritime Research Laboratory**

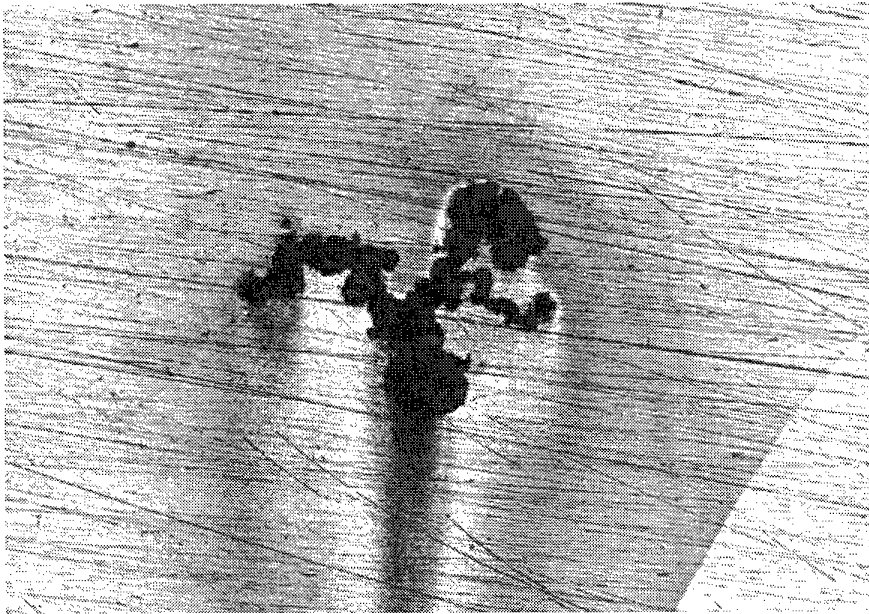
Figure 6. 'Wormlike' self-propagating filiform corrosion on the surface of D6ac steel.

The low growth rates of the corrosion produced a very strong and cohesive corrosion product that provided a site for self-propagating filiform corrosion. This developed where the corrosion product provided an interface under which an active site could react to produce more corrosion product. This extended the interface and moved the active site with time and resulted in wormlike trails of corrosion extending across the surface of the specimen (Figure 6).
